Too much moisture in the roof

A recently renovated home had a problem with mould in the roof cavity. BRANZ found moisture from a poorly ventilated bathroom was passing through downlights into an airtight roof space. It's a lesson for others.

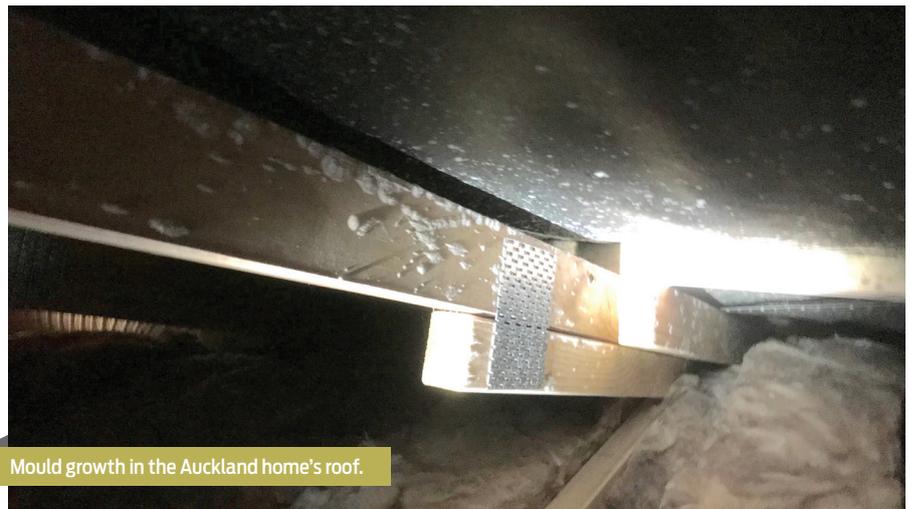
Mould growth in the Auckland home's roof.

The airtightness measurement revealed that this gable roof space was on the airtight side

and would not allow enough air exchange for the moisture load it was exposed to.
